# Crime scene investigation and dynamic reconstruction: importance of synergic collaboration between forensic pathology and digital reconstruction for work-related fatalities

*Soud Lek 2021; 66(1): 2–5*

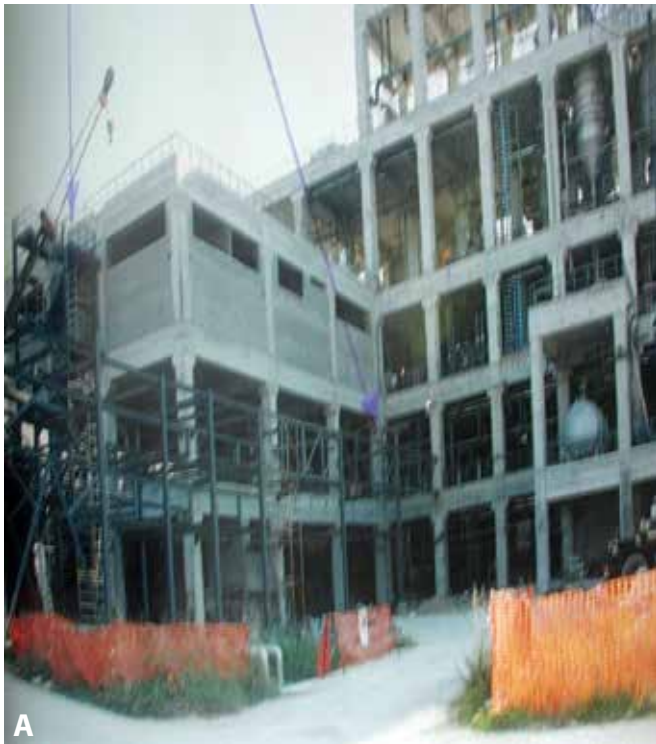
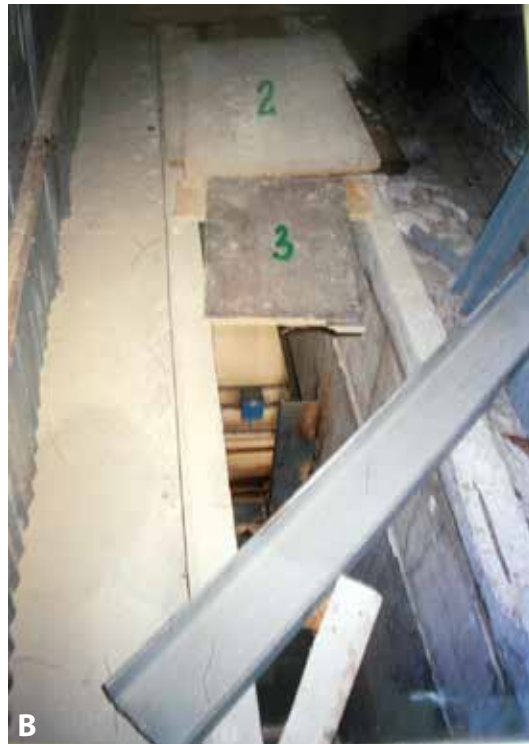
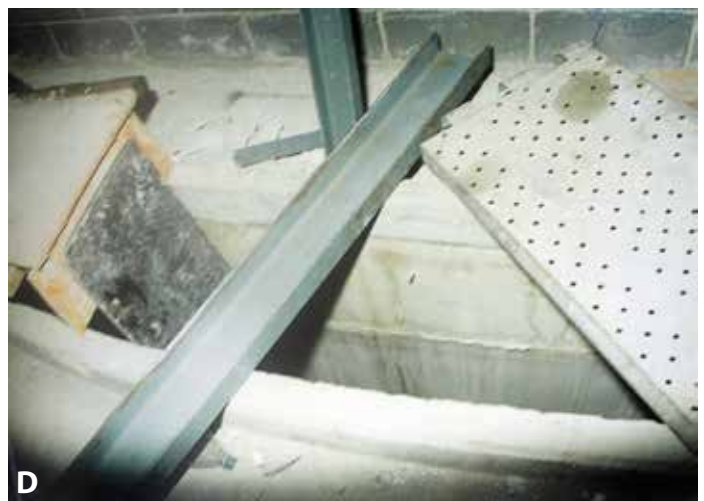
**Figure 1. A, B, D:** building where the accident took place. **C:** linear laceration involving the skin and subcutaneous tissues, 8 cm long, in the right frontal-zygomatic region.

was sufficiently wide to allow equipment to be transferred between the floors. Some wooden planks had also fallen together with the worker. No one heard the first worker crying out as he fell (Figure 1A, B, D).

A construction worker at an industrial building site had been directed by another company employee to carry an iron beam, which was 36 kg in weight and 100 cm in length, from the first floor to the second floor. After a short time, the second worker, who was on the first floor, heard a loud noise: it sounded as if something had fallen from above. He went to another part of the first floor, where he found his coworker lying prone in a pool of blood: the first worker was at the base of metal tube scaffolding, which extended from the first to the second floor. The second worker realized that his workmate had fallen through a rectangular trapdoor (50 cm x 150 cm), which
